32 Brookside Avenue
Block 14, Lot 759.02
Borough of Demarest, Bergen County, NJ
Joint Land Use Board Application - Engineering Review
Colliers Engineering & Design Project No. DEZ0046

Engineering Review

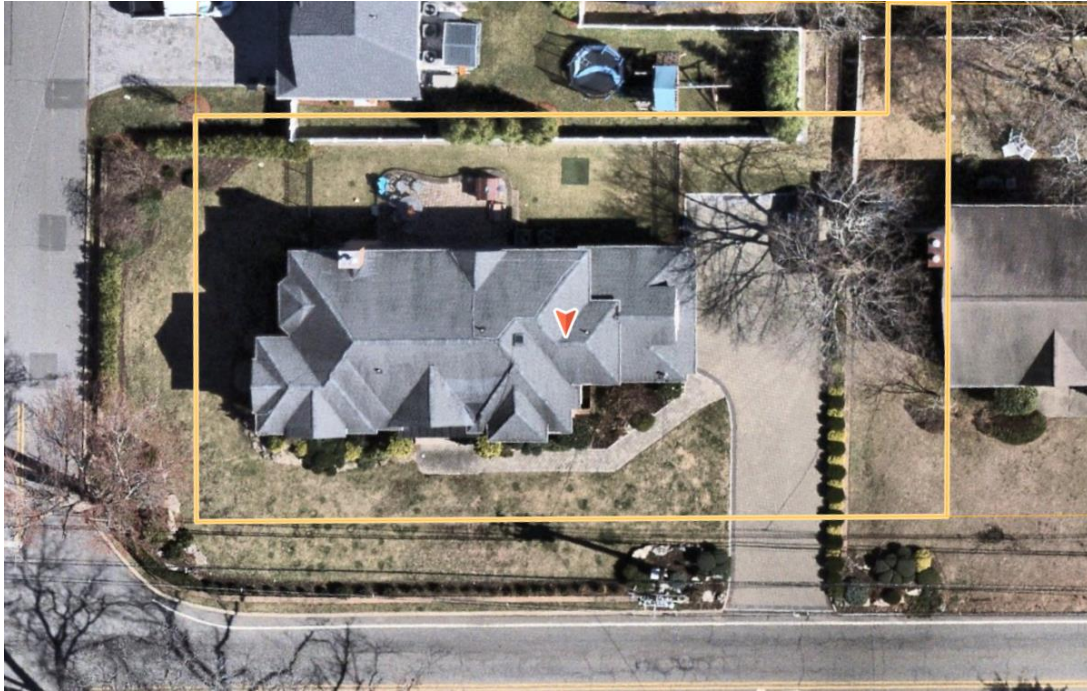
2. It appears an expanded rear patio area was constructed sometime in 2017 which occupied almost the entire rear yard area. This patio was removed in late summer/early fall of 2024. See imagery below.

Historical Imagery – Conditions from 2024 – Current
