December 1, 2025

32 Brookside Avenue  
Block 14, Lot 759.02  
Borough of Demarest, Bergen County, NJ  
Joint Land Use Board Application - Engineering Review #2  
Colliers Engineering & Design Project No. DEZ0046

## Engineering Review

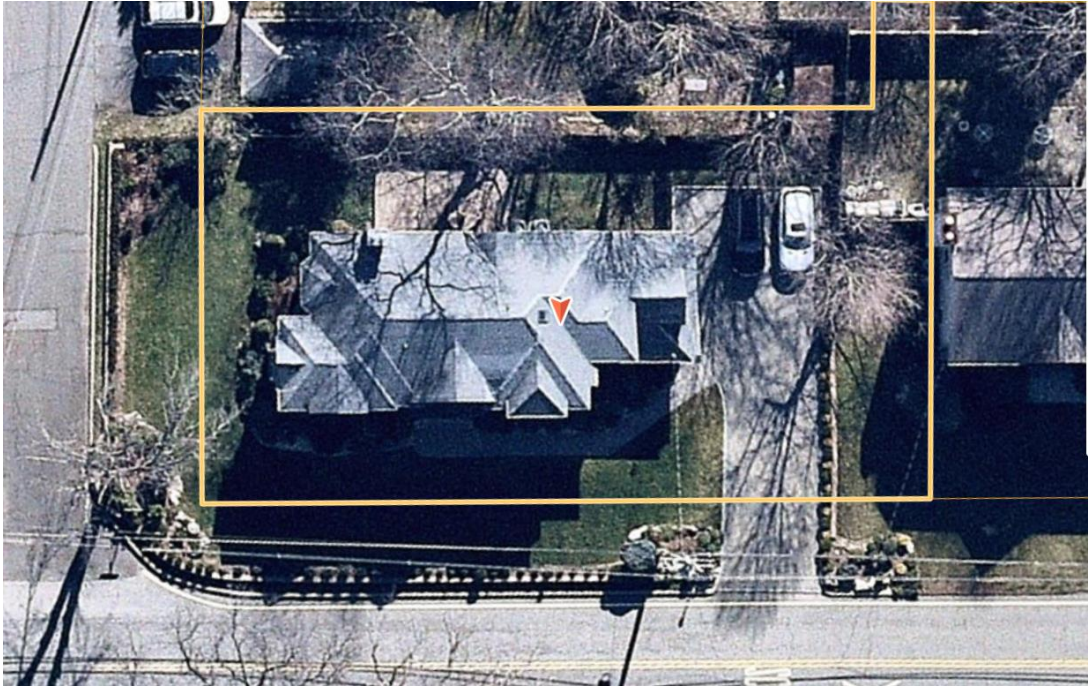
Historical Imagery – Conditions from 2014 - 2017

- ### G. Historical Imagery
1. We note that historical imagery suggests that the dwelling, rear, patio, driveway, and walkways existed as they are shown dating back to 2014 (no imagery is available prior to this date). See imagery below.

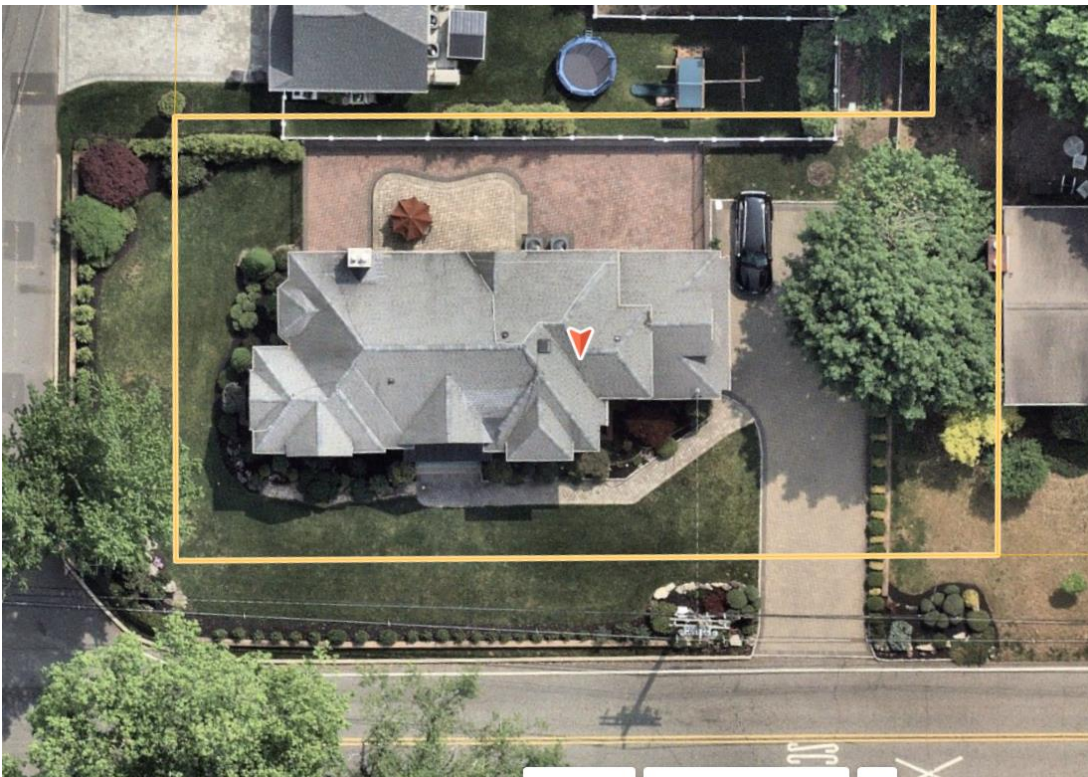
Historical Imagery – Conditions from 2017 - 2024

2. It appears an expanded rear patio area was constructed sometime in 2017 which occupied almost the entire rear yard area. This patio was removed in late summer/early fall of 2024. See imagery below.
